# Concrete Pavement Troubleshooting

NHI Real Solutions  
Presentation  
Oct 23 , 2008

**Dr. Peter Taylor P.E. & Dale Harrington P.E.**

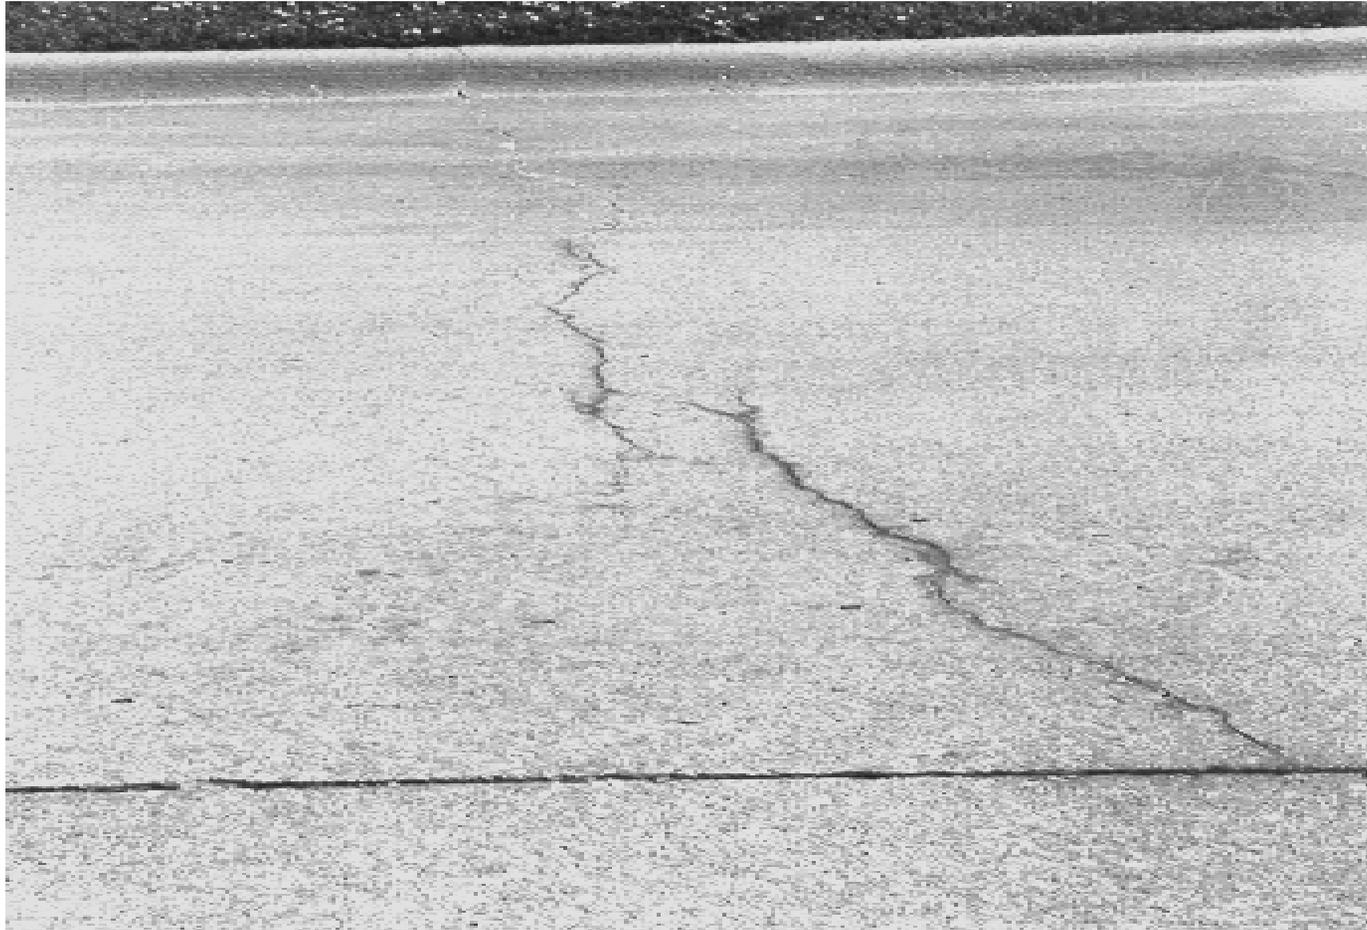
# Early Age Transverse Crack

- It's October and warm
- Everything is going well, until...
- One 200-yard section is cracked transversely every 6 feet

- Sharp drop in temperature when concrete is at its hottest
- Added surface moisture which goes into expansion

- Keep it covered
- Early entry sawing

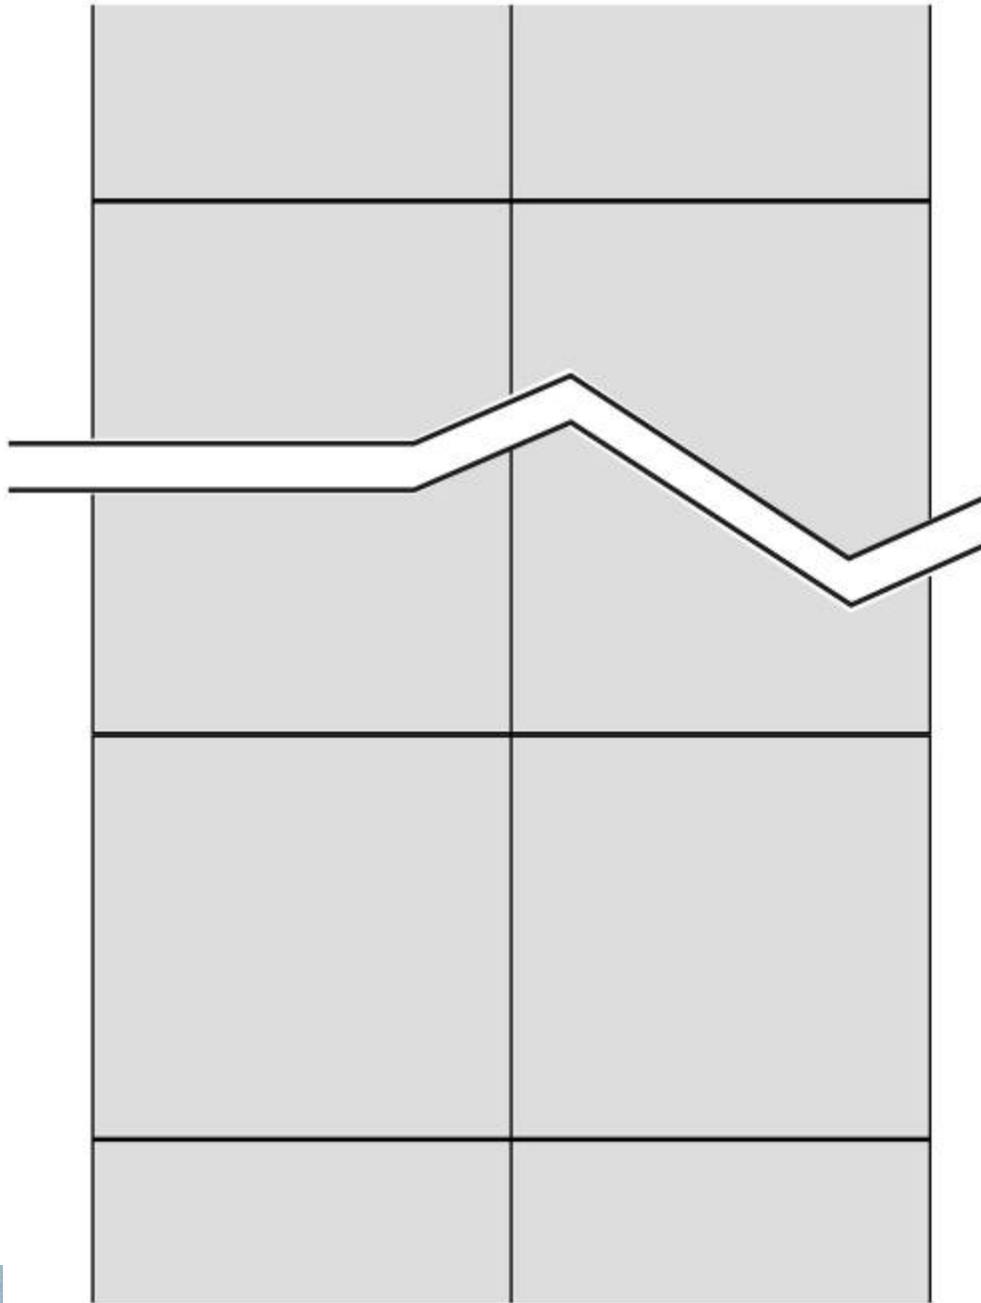
2 lane existing roadway

- It's late October with beautiful warm days and frost at night
- You have placed 2 lanes and now are adding the third
- You see transverse cracks, about a foot or so long, taking off from the joint in the new lanes lanes, and heading for the cold joint next to the previously placed lanes
- They only occur about every 3<sup>rd</sup> or 4<sup>th</sup> joint
- They only occur in the first half of the day's pour

- Thermal expansion or later contraction in the existing lanes puts stress on the new concrete. At the same time, shrinkage in the fresh concrete or later thermal expansion put an additive stress on the slab at the tie bars

- Saw as soon as possible, with an early entry saw
- Start paving later in the day
